Project Profile

Site Name: Lancaster University – Bowland Building

Roofing System: High performance felt system to higher level pod roofs
High performance odourless coating system to lower level walkway areas
Render repairs and coating system to walls of pod buildings

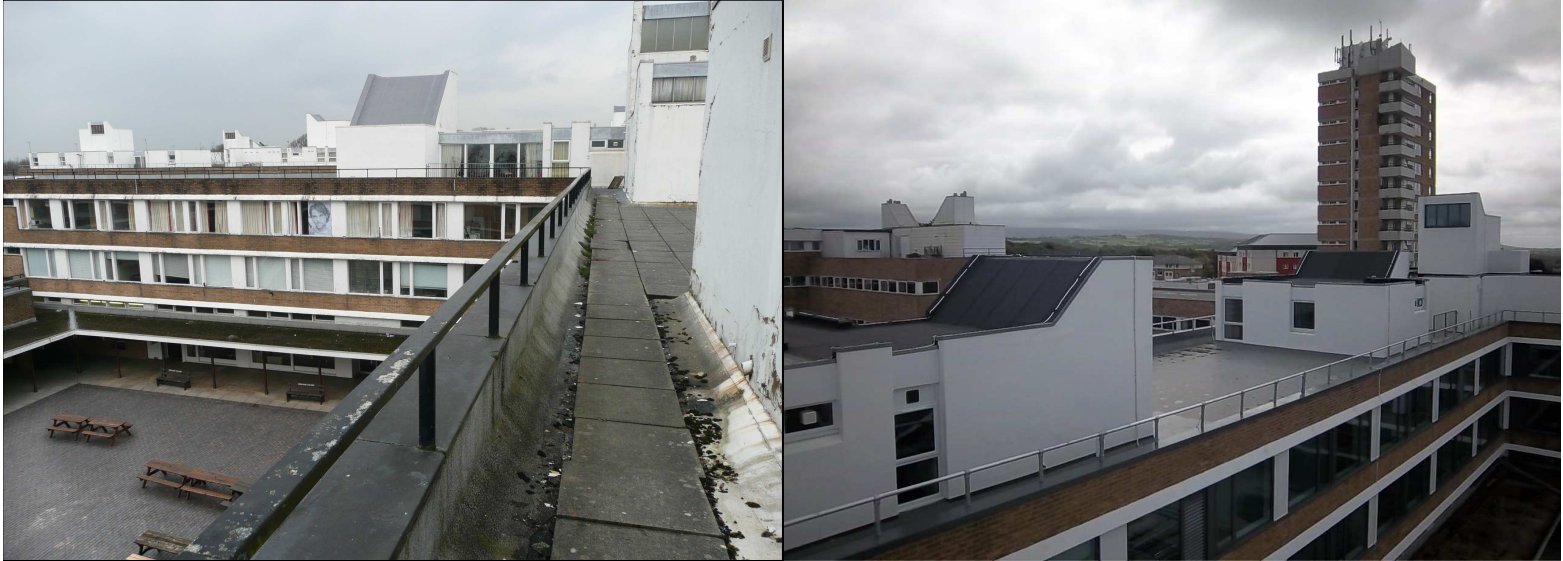
The PVC single ply roof membrane to the higher level pod roofs had failed causing extensive water ingress.

The lower level walkway areas were a combination of built up felt and mastic asphalt which had failed. The flags to the walkways were badly installed and were impeding drainage. The fixed handrail to the roof perimeter no longer conformed to HSE requirements.

The high level pod roofs were stripped to the deck and a new insulated high performance single layer elastomeric felt system was installed. The walls to the pod buildings were repaired and coated with a reinforced elastomeric decorative coating system.

The defective handrail was removed and a new permanent handrail was installed incorporating new aluminium wall cappings.

The flags to the lower level walkways and balconies were removed and a new trafficable coating system was installed.
