Project Profile

Site Name: Manchester Airport, World Freight Terminal

Roofing System: Giromax Seamsil & Delcote Coatings System

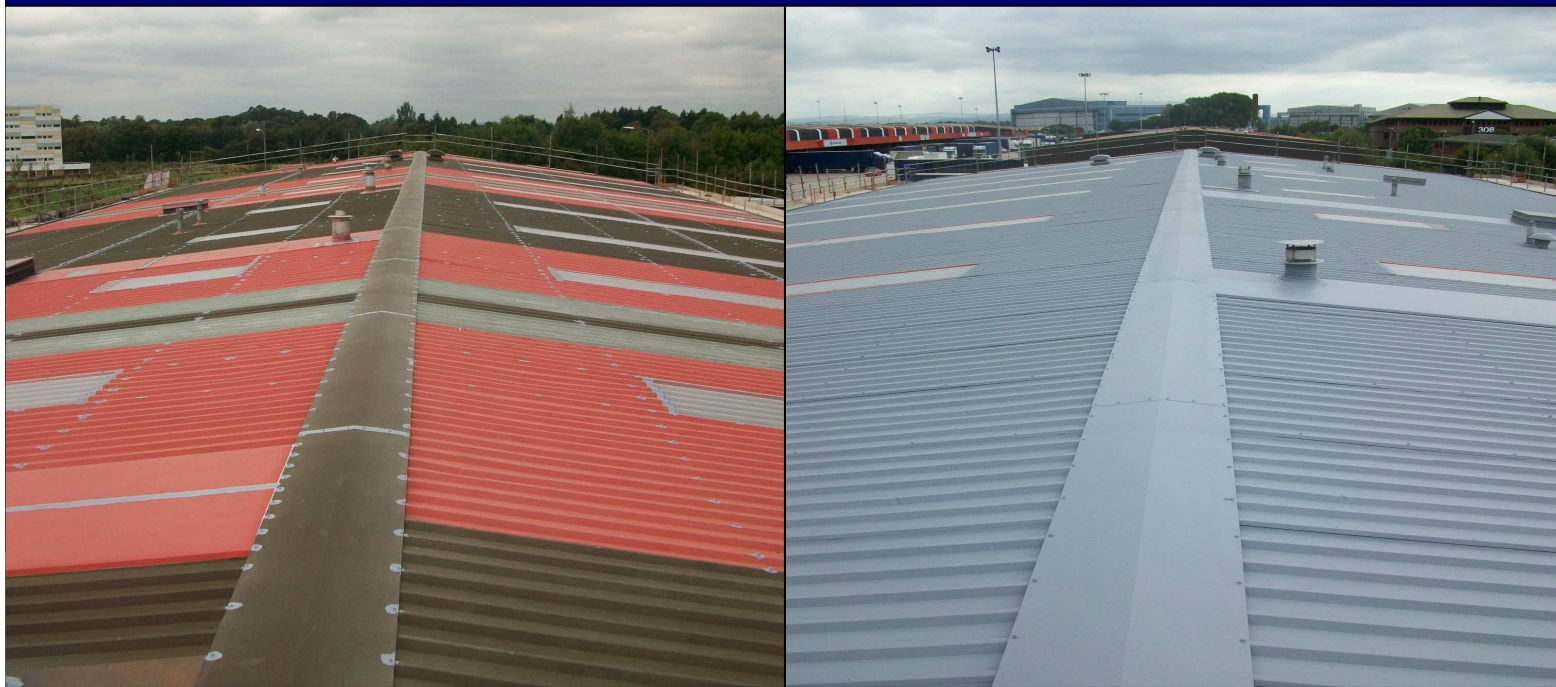
The existing 5,500m² of plastisol coated profile metal cladding to the roof and walls was experiencing wide spread failure, as were the gutters. Problems included cut edge corrosion, coating delamination and coating discolouration. The cladding to the rear elevation had numerous areas of mechanical damage. The roof transluents were fragile, aged and degraded.

Initially all transluents were replaced with new non-fragile transluents. The areas of mechanical damage were repaired with new plastisol coated profile metal sheets and flashings. All cut edge corrosion was treated with the Corus approved Giromax Seamsil system. Finally all the roof and wall cladding, as well as the gutters, were treated with the Giromax Delcote Silicone coating system.
