# Project Profile

**Site Name: Bolton Street Site, Liverpool**

Roofing System: High Performance Liquid Coating System

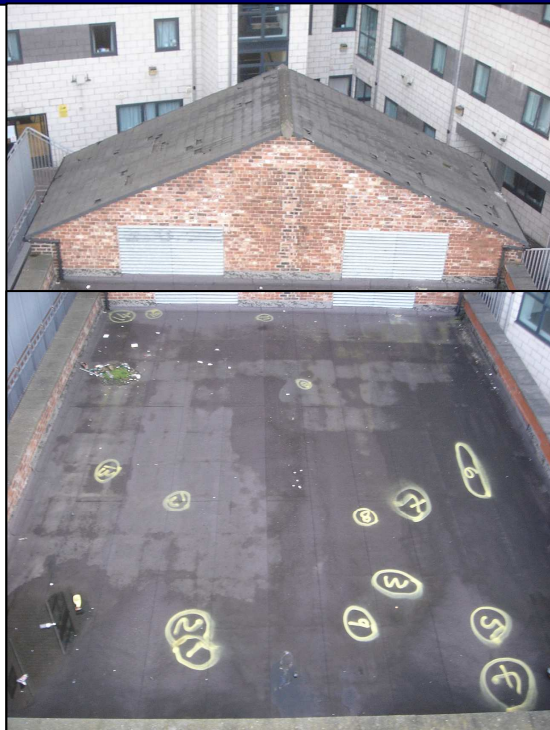
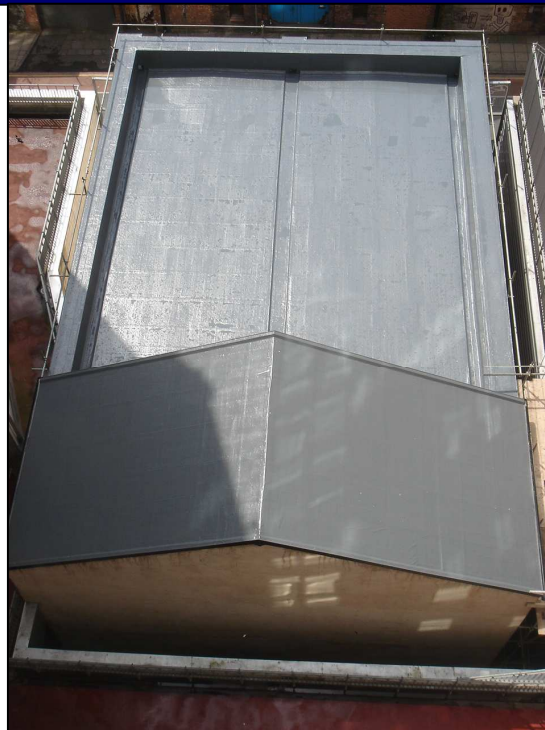
The pitched tiled roof to the student accommodation was severely dilapidated through vandalism, with symptoms including widespread blistering to the flat roof and physical holes in the pitched roof.

Due to the sensitive nature of the site together with the working logistics of a busy main street in the city centre of Liverpool, a cold applied liquid polyurethane coating system was specified for the refurbishment of these roof areas, together with the installation of Ecotherm insulation boards to the flat roof area.

Weatherproofing Advisors also incorporated rainwater gulleys to their installation scheme to maximise water egress from the flat roof area.
